Manhole Inspection Summary

Manhole # S65A1_004MH

Location Address: **2200 Broening Hwy.**

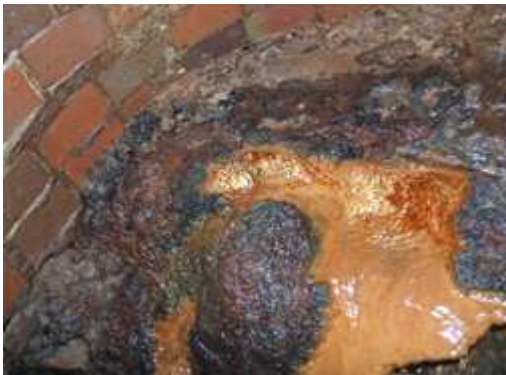
Defect 4

broken 7oclock pipe

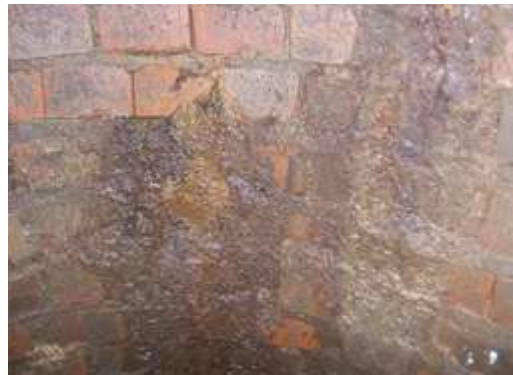
Defect 2

Infiltration: ☐ None ☒ **Joint** ☐ Cracks ☒ **Mortar** ☐ Roots ☐ Wall

infiltration in barrel

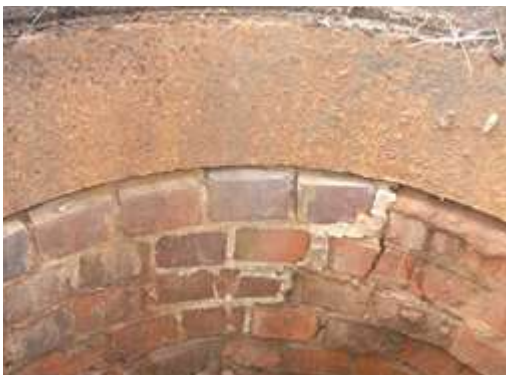
Defect 5

Condition: ☐ Sound ☐ Cracked ☐ Root Intrusion ☒ **Loose Brick** ☐ Deteriorated

loose bricks under frame

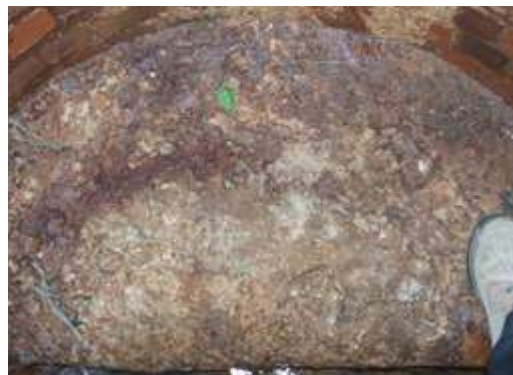
Defect 3

Condition: ☐ Sound ☐ Cracked ☐ Root Intrusion ☐ Deteriorated ☐ Leaks ☒ **Debris**

debris on bench

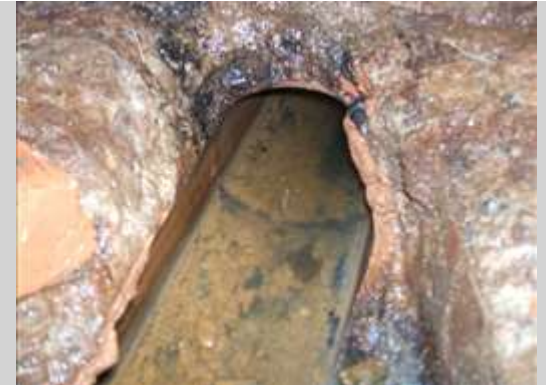
12 O'Clock Outflow

Deposits: ☐ None ☐ **Mud** ☒ **Sludge** ☐ Debris ☐ Grease

Silt Depth: **0.5** (in.) Deposits Extent: **Light**

Infiltration: **None** Pipe Seal Cond: **Broken**

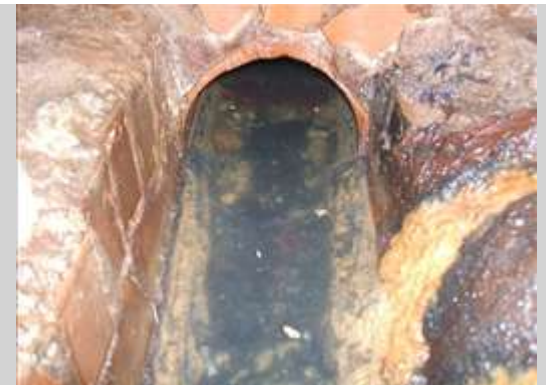
6 O'Clock Inflow

Deposits: ☐ None ☐ **Mud** ☒ **Sludge** ☐ Debris ☐ Grease

Silt Depth: **0.5** (in.) Deposits Extent: **Light**

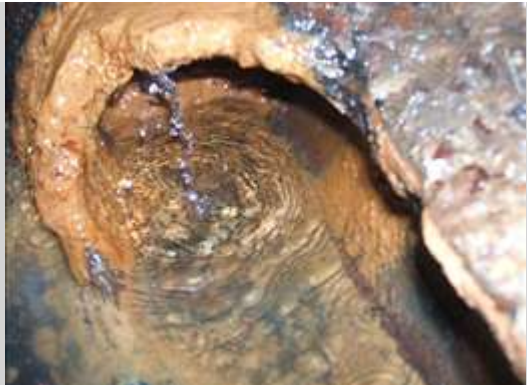
7 O'Clock Inflow

Pipe Height: 6 (in.) Rod Only
Pipe Material: **Clay** ☐ Pipe Lined
Invert Depth: **17.42** (ft.) Flow Characteristics: **Slow**
Deposits: ☐ None ☒ **Mud** ☒ **Sludge** ☐ Debris ☐ Grease
Silt Depth: **2** (in.) Deposits Extent: **Light**
Infiltration: **None** Pipe Seal Cond: **Broken**

Connects To: **Stub connection / abandoned**
☐ Possible Illicit Connection
